Renewable Energy Systems Limited

Upper Ogmore Wind Farm

Ground Investigation report

Project no. 371718-01 (01)

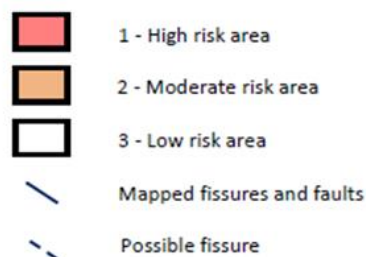
Illustration 3: Risk zones based on the criteria in Table 1 (after N.A. Brown) with turbine layout PWALuog033 and amended site boundary.

Since issue of the above reports, it has become necessary, due to a number of constraints, for RES to consider alternative locations for turbines T3, T4 and T5 and amend the site boundary. Revised turbine locations are given in Turbine Layout No. PWALuog033, given in RES Turbine Layout Drawing No. 02959D0001-08, shown as **Figure 2**. The risk zone image presented in **Illustration 2** is updated in **Illustration 3** to include the current PWALuog033 turbine layout and amended site boundary.

The remainder of this report documents investigations at the Turbine Layout No. PWALuog033 T3, T4 and T5 turbine locations to assess the level of risk from potential geological hazards.

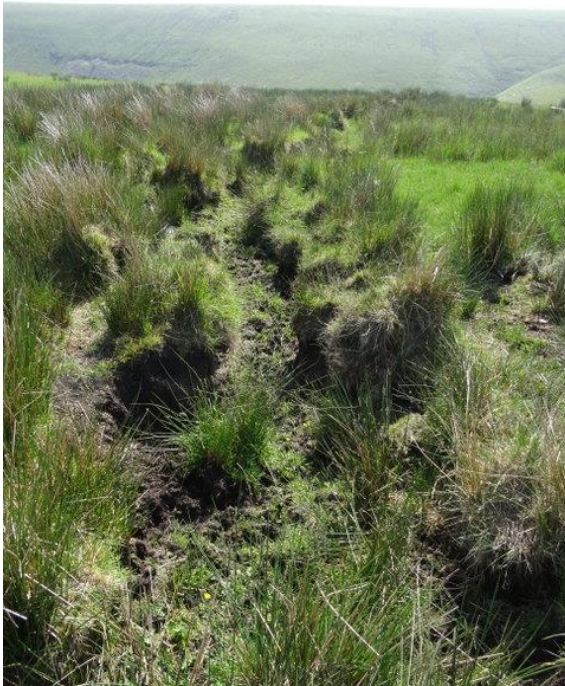
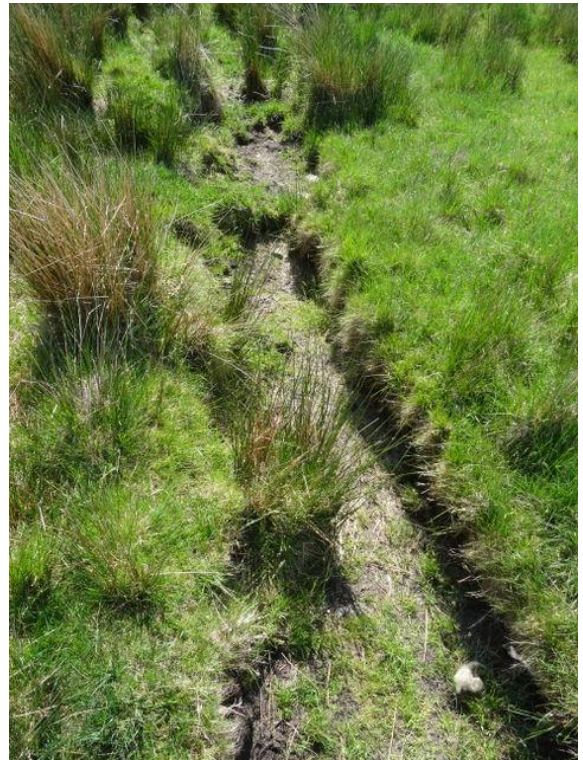
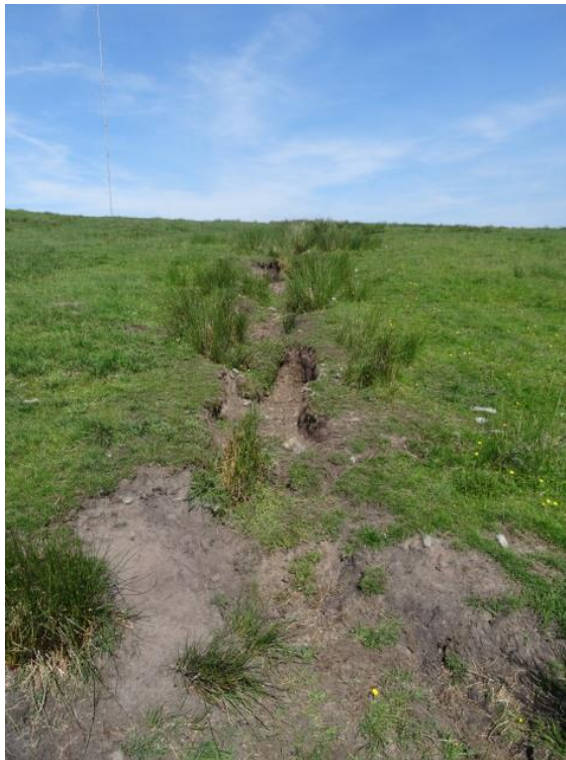
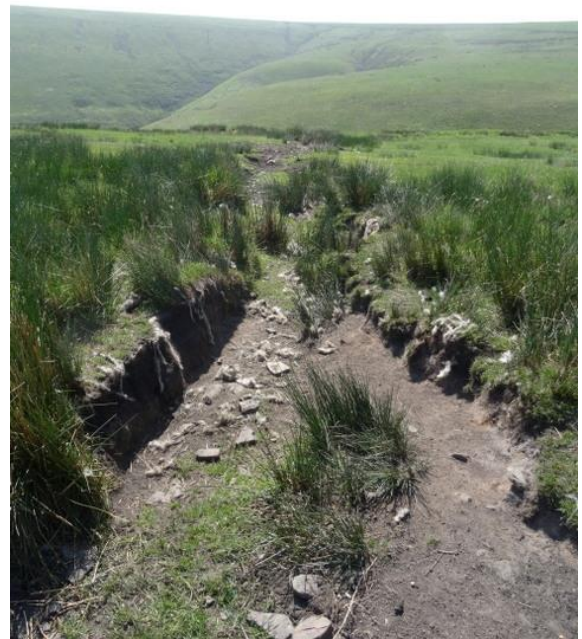
This feature is relatively linear and varies in width and depth. Towards its northeastern end in the boggy area, it is narrow, up to 200mm wide, and, at least locally, may extend to depths of 1m with a soft boggy/peaty sediment partial infill. Traced west-southwestwards the width generally broadens and locally reaches a metre or more.

The sides are generally formed from vertical faces, locally up to 300mm to 400mm high, of bare soil, and the base of the feature is generally flat and level and locally contains the same vegetation (grasses and tussocks) as the adjacent ground. No surface features were observed that are indicative of running water (e.g. erosion channels/runnels, washed in materials). The above-described features are illustrated in

the photographs below. The mapped locations of the observed features are shown on **Figure 4** and the co-ordinates given in **Table 2**.

Notwithstanding the above information provided by the landowner, there are certain visual morphological characteristics associated with this feature that would otherwise be consistent with some form of fracture-related ground displacement, or potentially ground collapse from sub-surface drainage of the peat.

Given that this feature lies on an alignment with the T5 turbine location and there is a risk, albeit low, that this feature may be in some way related to fissuring (either pre- or post-drainage channel construction) it would be prudent to investigate this feature directly during detailed design to confirm the information provided by the landowner and rule out the risk from fissuring.

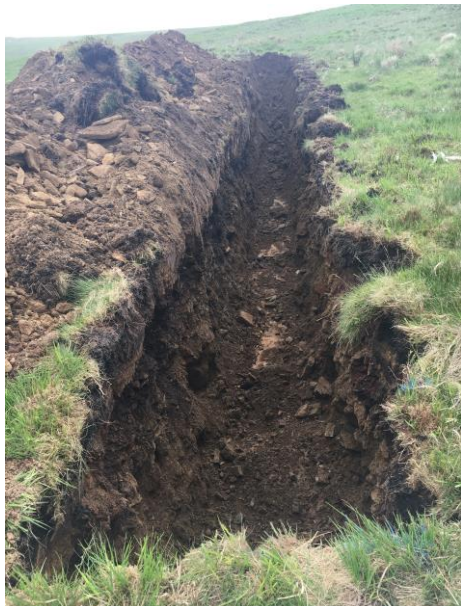
PHOTOGRAPHIC LOG		
Photo no. 1	Date: 05/06/18

Direction photo taken: Looking southwest		
Description: T3-TT1

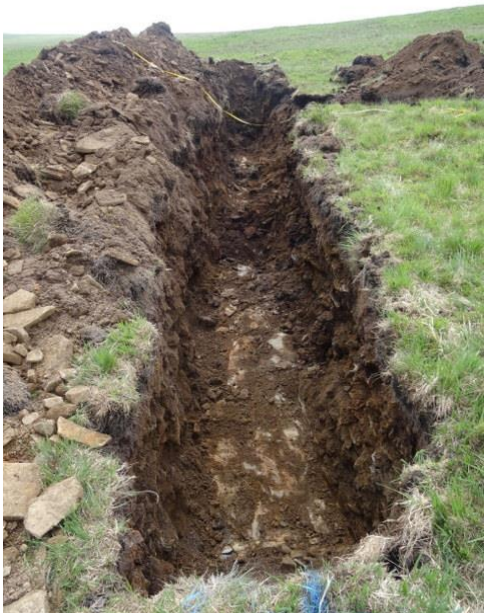
Photo No. 2	Date: 05/06/18

Direction photo taken: Looking southwest		
Description: T3-TT2

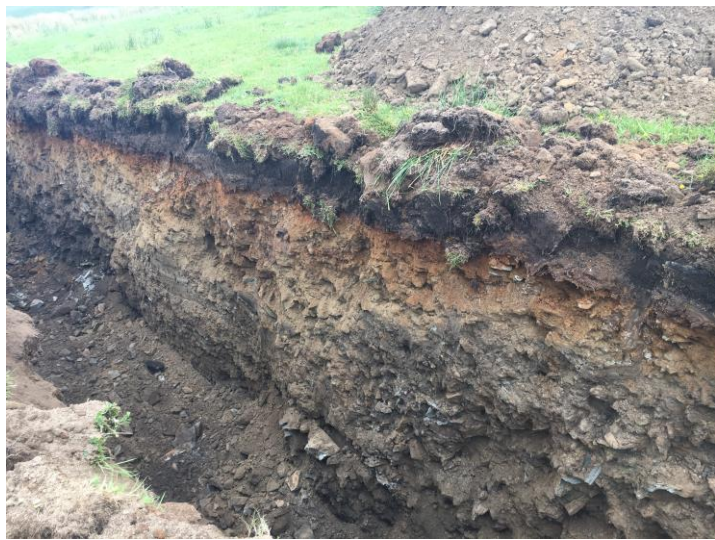
Photo No. 6	Date: 05/06/18

Direction Photo Taken: southeast		
Description: T5-TT2

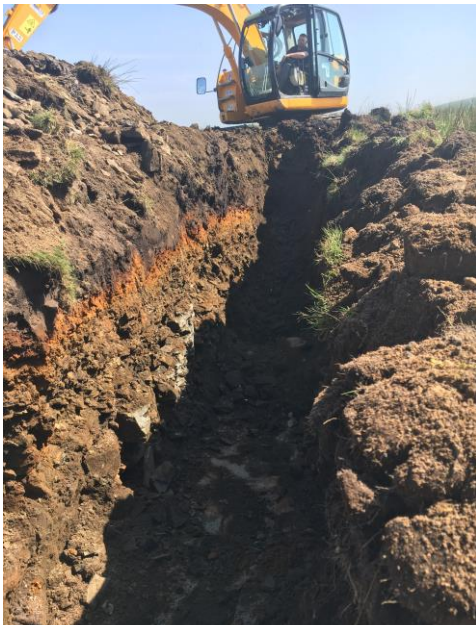
Photo No. 7	Date: 06/06/18

Direction Photo Taken: south		
Description: T5-TT3

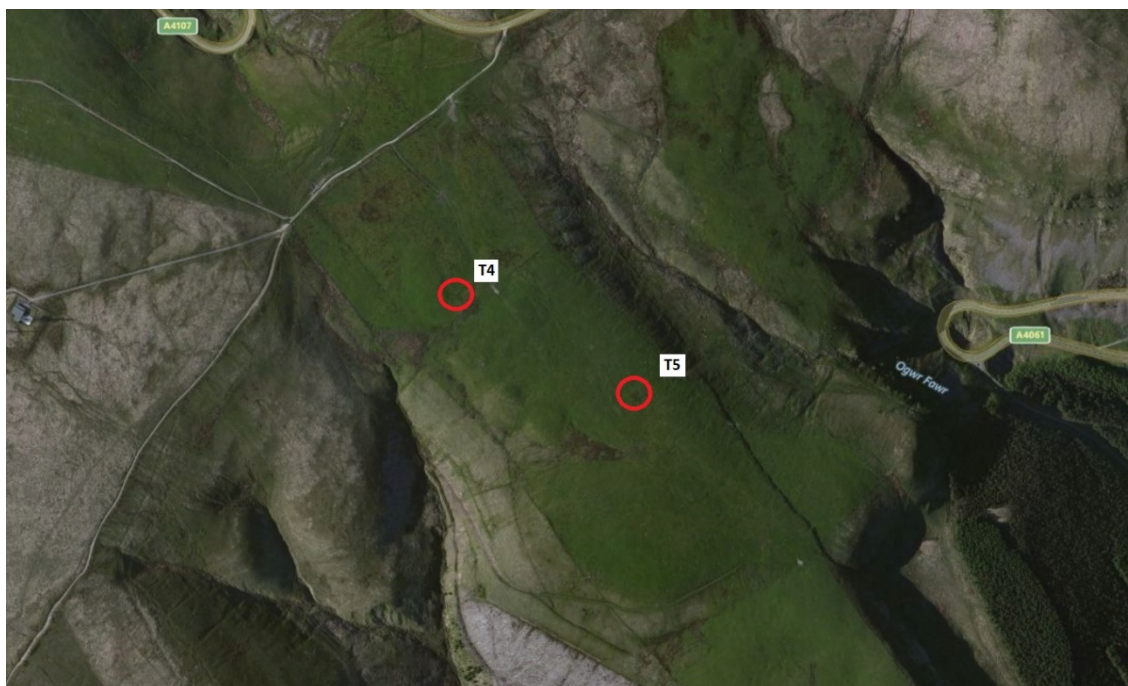
Figure 3.2 Aerial image showing approximate turbine positions. © Bing Maps 2018.

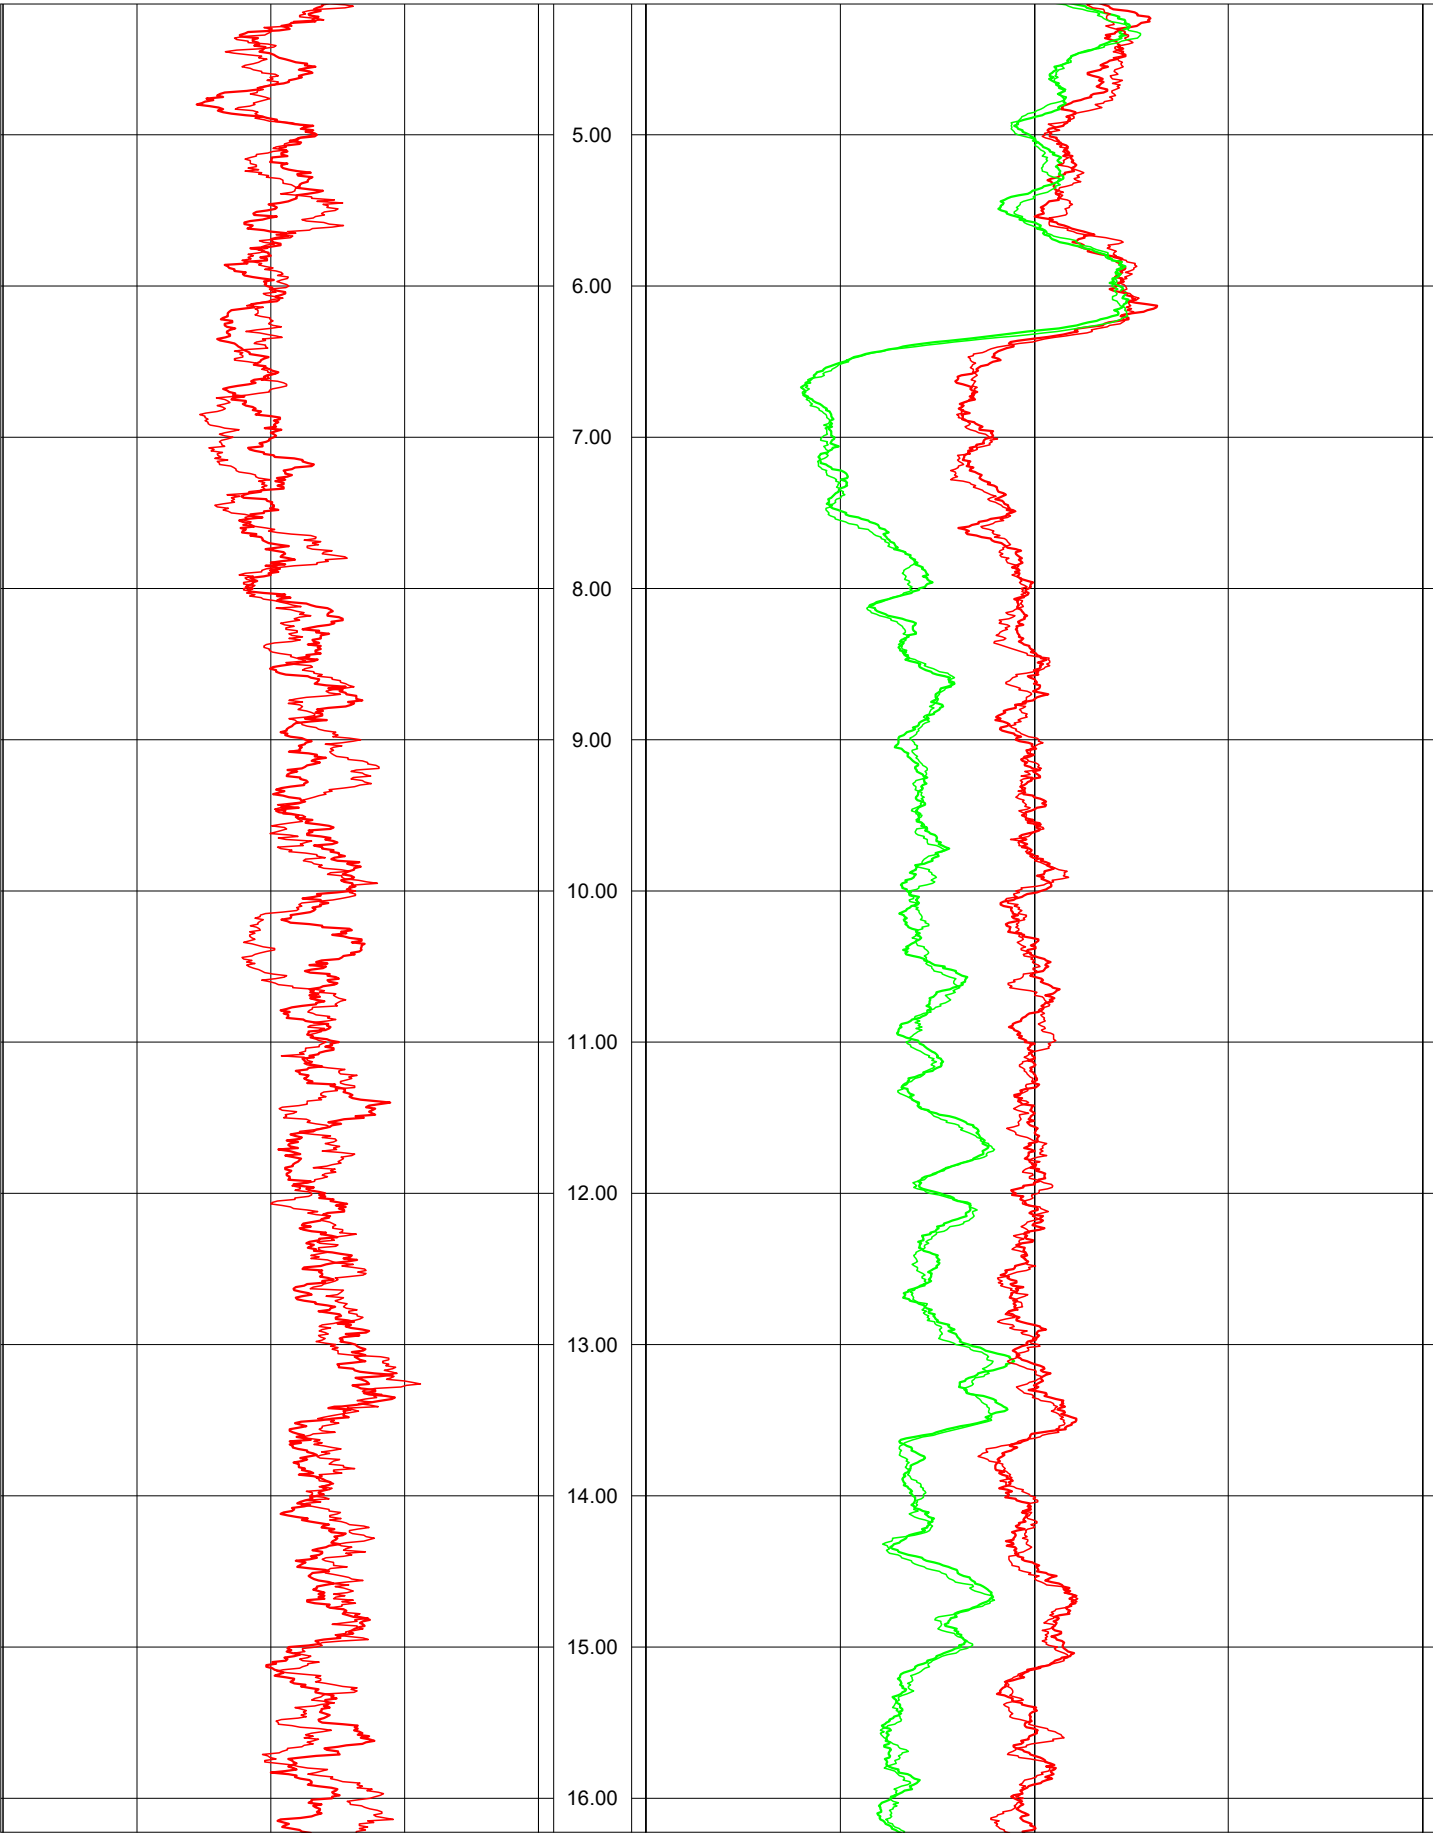
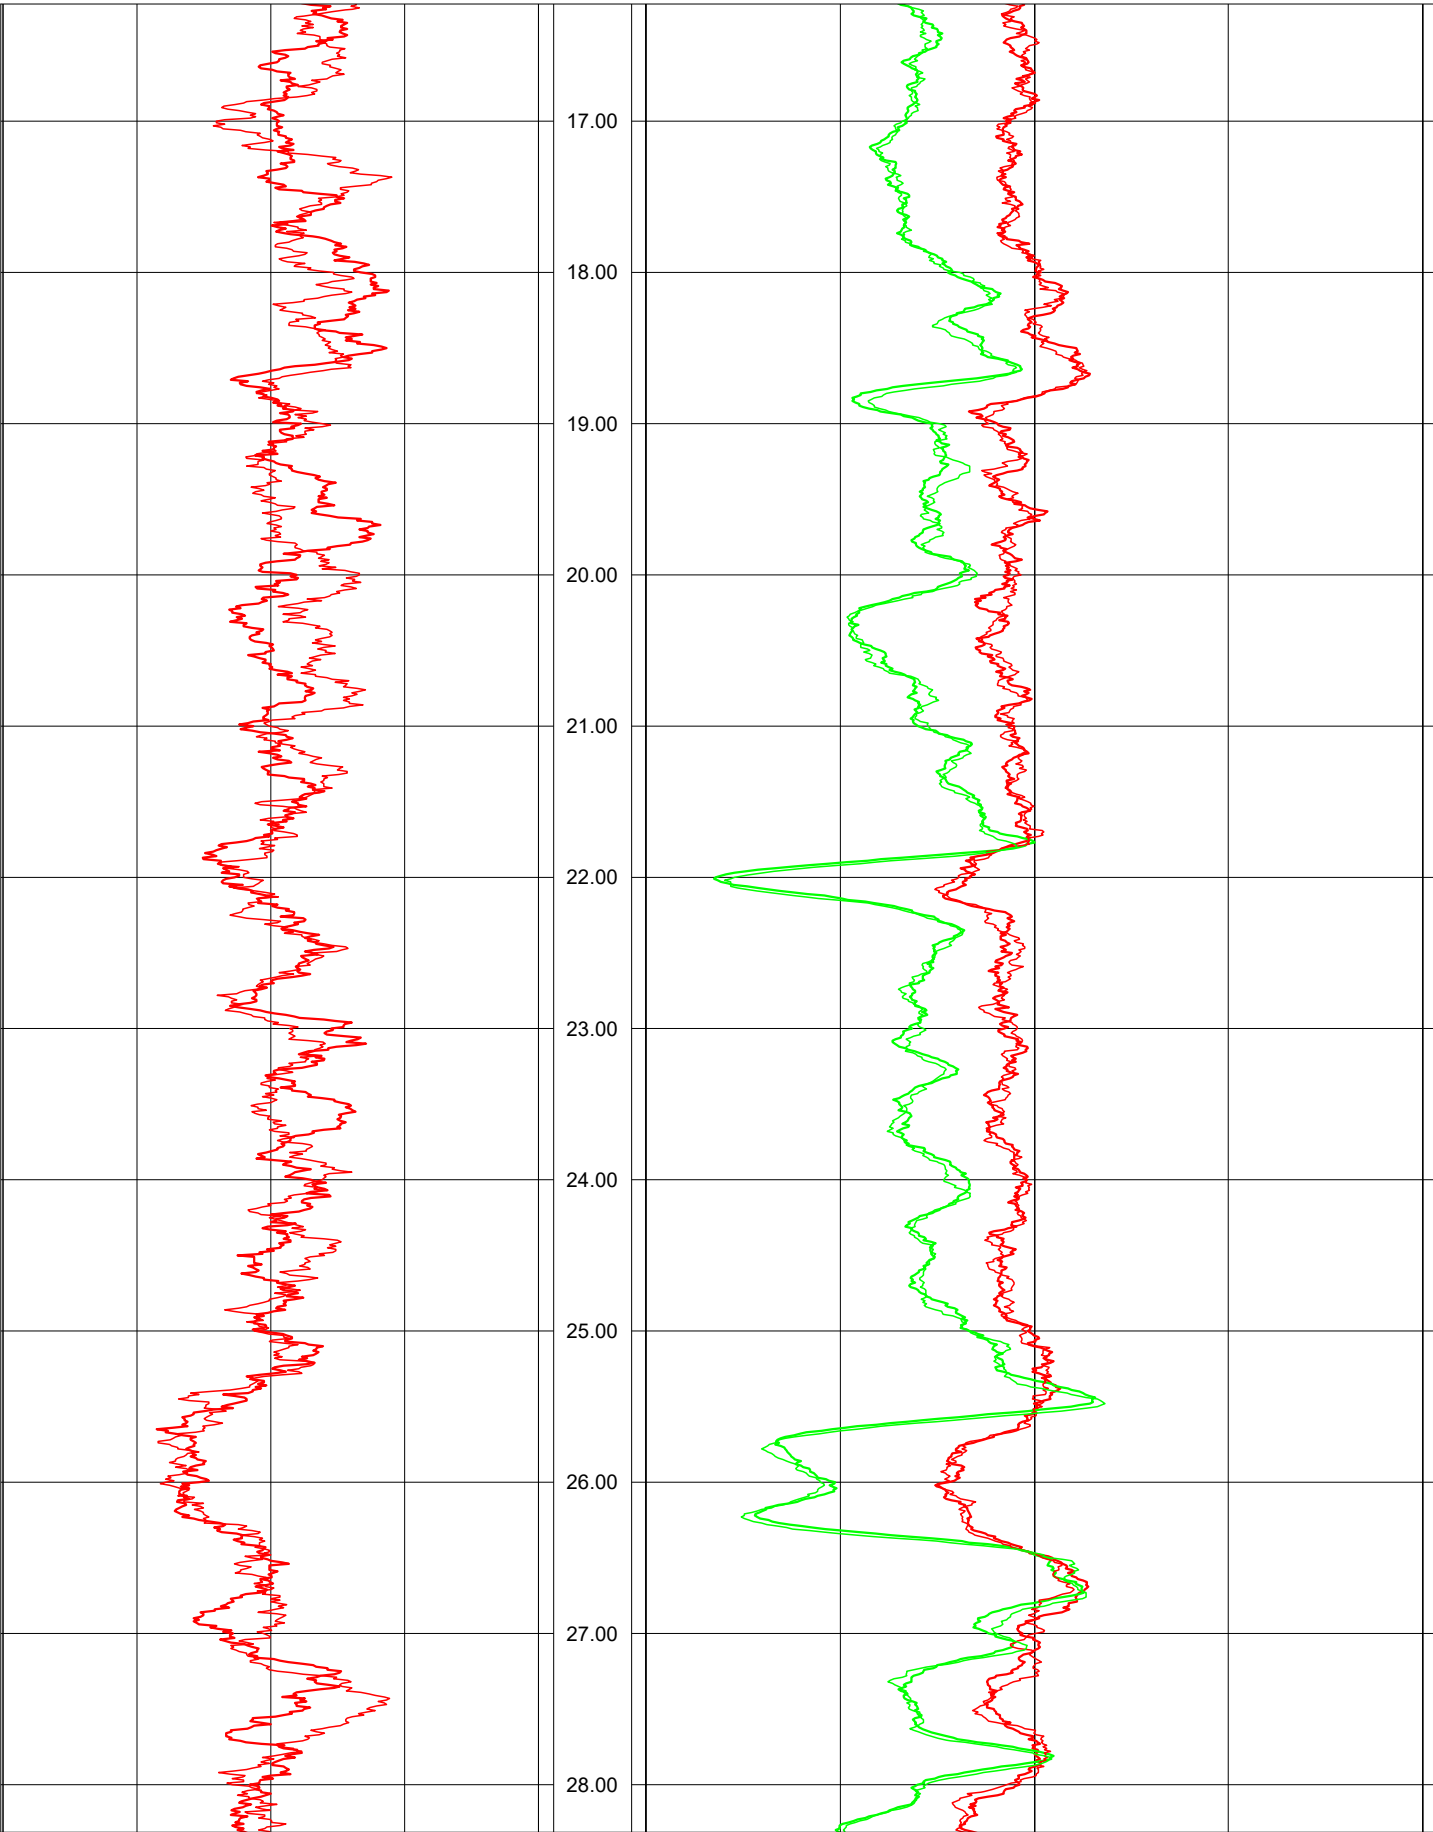
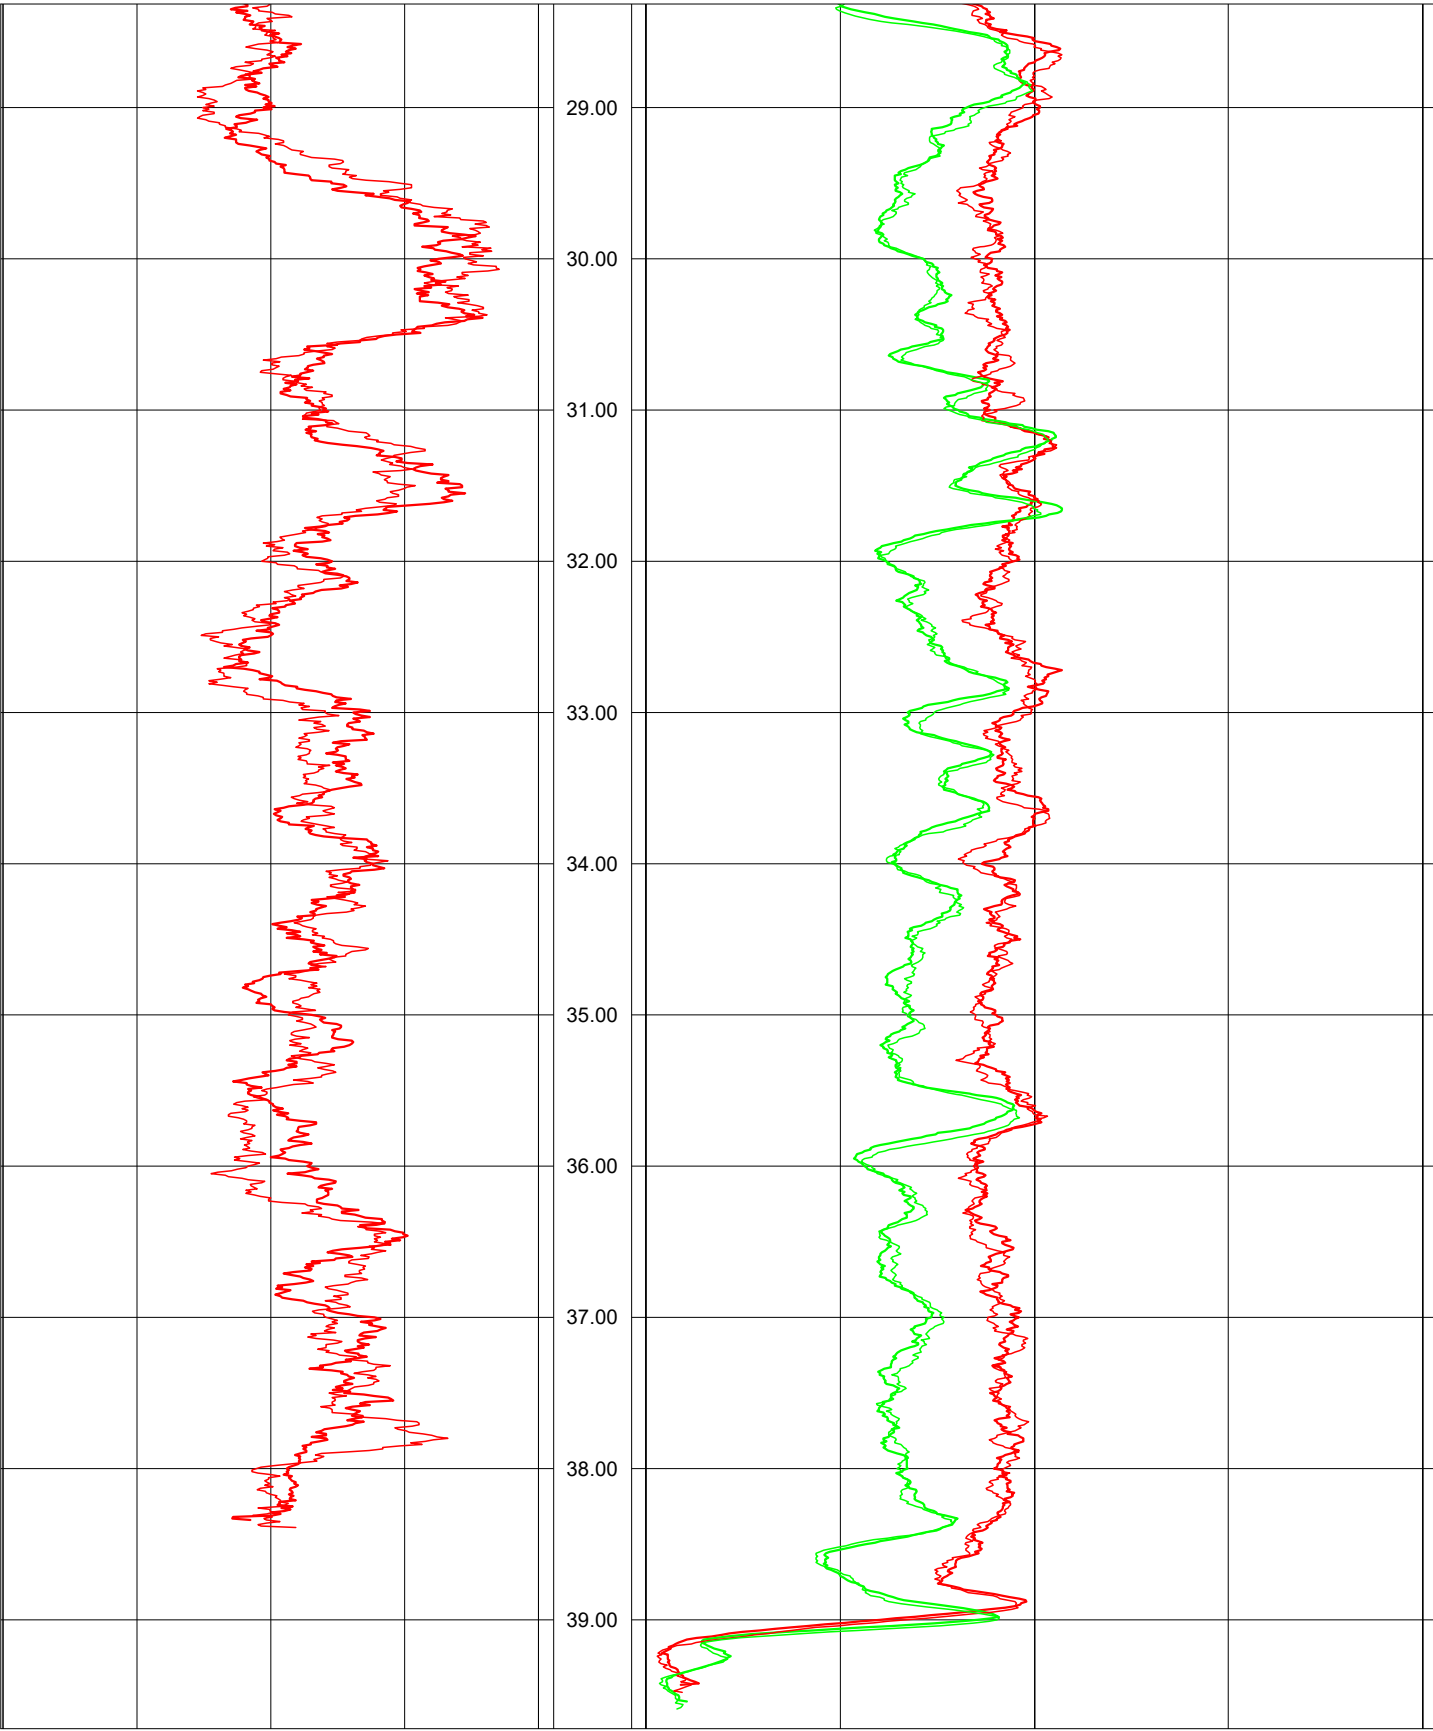
EUROPEAN GEOPHYSICAL SERVICES LTD					
	Client: RSK				Log Type:	
	Borehole: T5-BH3				Trisonde	
Location: Ogmore Wind Farm		Area: South Wales		Grid Ref:		Elevation:
Drilled Depth: (m)	40.0	Date:		08.06.18		
Logged Depth: (m)	39.7	Recorded By:		R. Powell		
Logging Datum:	Ground Level	Remarks: Inclined BH Ref:				
Logged Interval: (m)	0.8 - 39.7					
Fluid Level: (m)						
BOREHOLE RECORD			CASING RECORD			
Bit: (mm)	From: (m)	To: (m)	Type	Size: (mm)	From: (m)	To: (m)
			PVC	50	0.0	40.0
<div> <div> Gam Depth 0 100 1m:50m </div> <div> LSD 0 5000 </div> </div> <div> <div> CPS Gam r </div> <div> CPS HRD </div> </div> <div> <div> 0 100 </div> <div> 30000 50000 </div> </div> <div> <div> 1000 5000 </div> <div> 30000 50000 </div> </div> <div> <div> CPS LSD r </div> <div> CPS HRD r </div> </div>
